'CANDLE' FILTRATION SERVICE HELPS LEADING BREWERY

SEE THE LIGHT

A comprehensive and efficient filtration service performed by Stella-Meta at Britain's oldest brewer, Shepherd Neame, has delivered sparkling results, showing a major improvement in production no less.

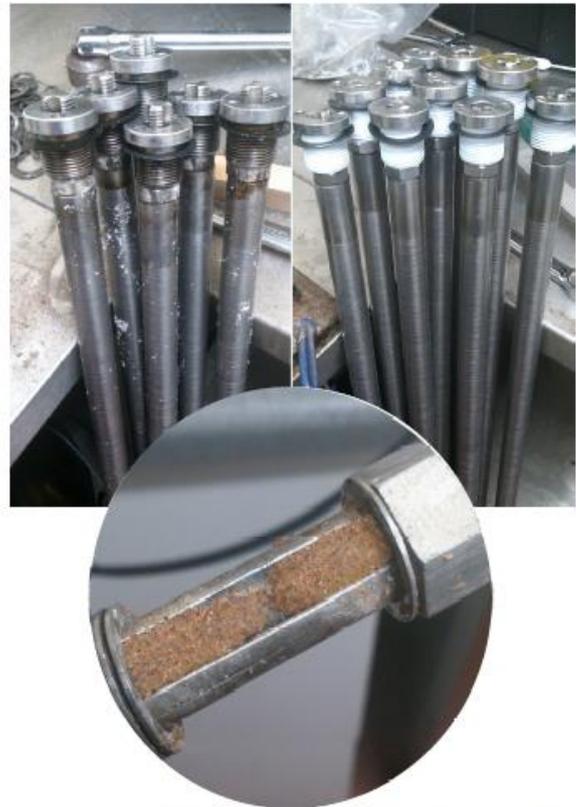
7/8-in x 43-in Metapacks before (left) and after servicing. The inset shows compacted filter powder trapped within clean side of pack prior to servicing.

"My first concern on seeing the top of the Metapacks for the first time was the extent of the fluted Brunton rod protruding through the pack adaptors," states Melvin Gilbert, Field Support Engineer at Stella-Meta. "This was due to insufficient Meta rings and excessive tensioning of the candles. The candles were also quite dirty and the area around the collar, lock-nut and adaptor showed signs of powder migration."

Upon closer inspection there was evidence of filter powder compacted around the bottom plate, a consequence of extended service periods. Also present was an unidentified black resin similar to granular carbon trapped within the fluted rod around the bottom plate. The particle size and shape of the resin made it impossible for it to pass from the dirty to the clean side of the candle. It was deduced that this contamination was entering the bright beer side of the candle during the filter's backwash cleaning cycle.

The process of removing 363 candles from the division plate then commenced. Due to excessive tensioning, many candles were seized and around 70-80 adaptors had to be re-tapped to rectify internal thread damage. With the candles de-tensioned and pack adaptors, locknuts and collars removed, inspection and cleaning could take place.

"Due to the initial protrusion of the Brunton rod through the adaptors, each candle had to be fully tensioned in order to establish how many rings required adding to each candle before reassembly," explains Melvin. "The candles were then de-tensioned before introducing the correct number of rings, and re-tensioned once more. In total, 5 to 15 Meta rings were added to each candle to ensure the correct assembly length. Following fitment of a new filter head joint, the head was replaced and secured via 32 stainless steel bolts to complete the pressure vessel assembly."

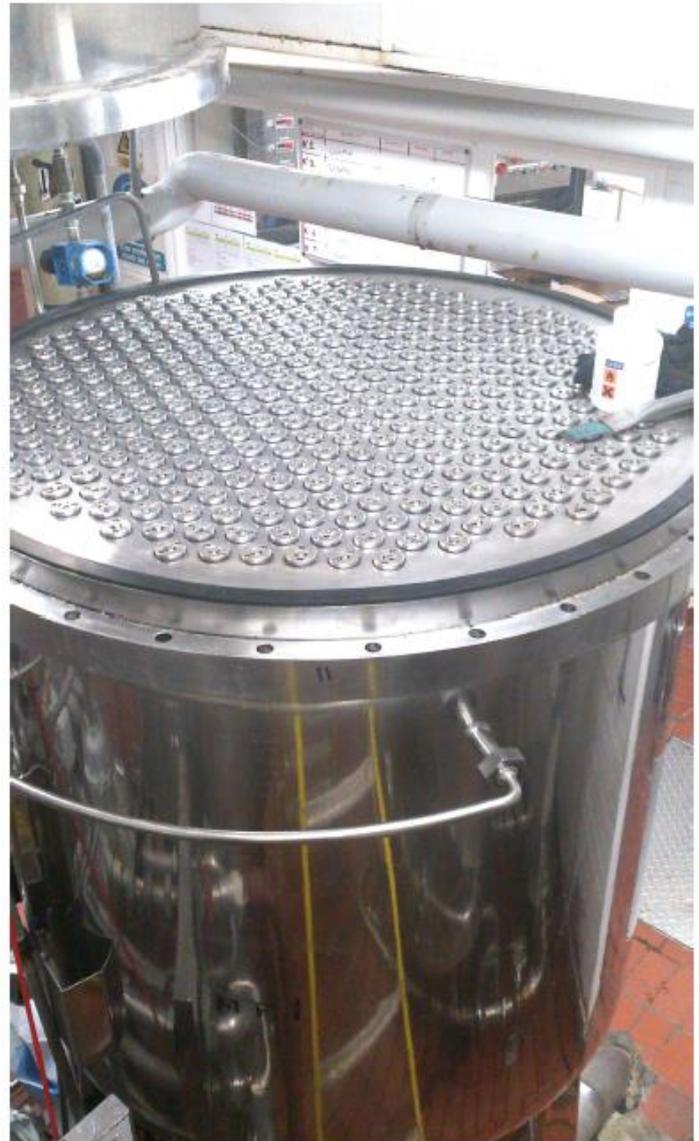
Metafilter with 363 candles serviced and replaced prior to fitment of filter head
